# STUDY OF CRACK INITIATION PHENOMENA ASSOCIATED WITH STRESS CORROSION OF ALUMINUM ALLOYS

FINAL SUMMARY REPORT

ALCOA RESEARCH LABORATORIES  
NEW KENSINGTON, PA

October 6, 1969

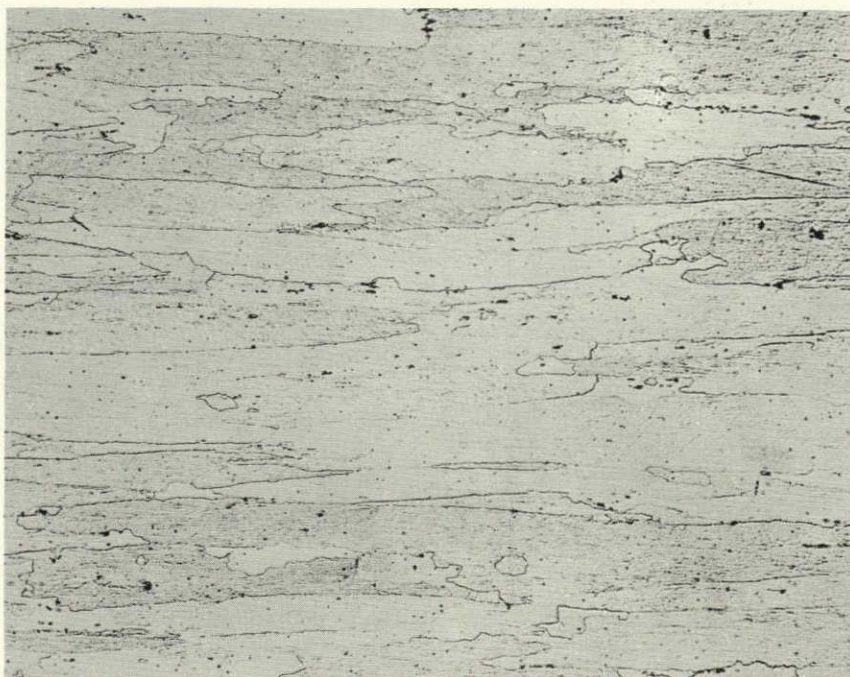
**Figure 4**

**Microstructure of longitudinal  
section of 2219-T87 plate.**

The structure of the T87 temper, produced by precipitation heat treating the T37 temper at 325 F, differed in two respects from that of the T851 temper. Copper depletion of the matrix was greater, as indicated by the lower grain contrast after etching (Fig. 4 - top). In addition, the matrix precipitation in the T87 temper was distributed generally and was not aligned along slip planes (Fig. 4 vs. Fig. 3). The changes in light microstructure were confined to the fine structures, because the constituent particles and large boundary precipitates are not affected by artificial aging.

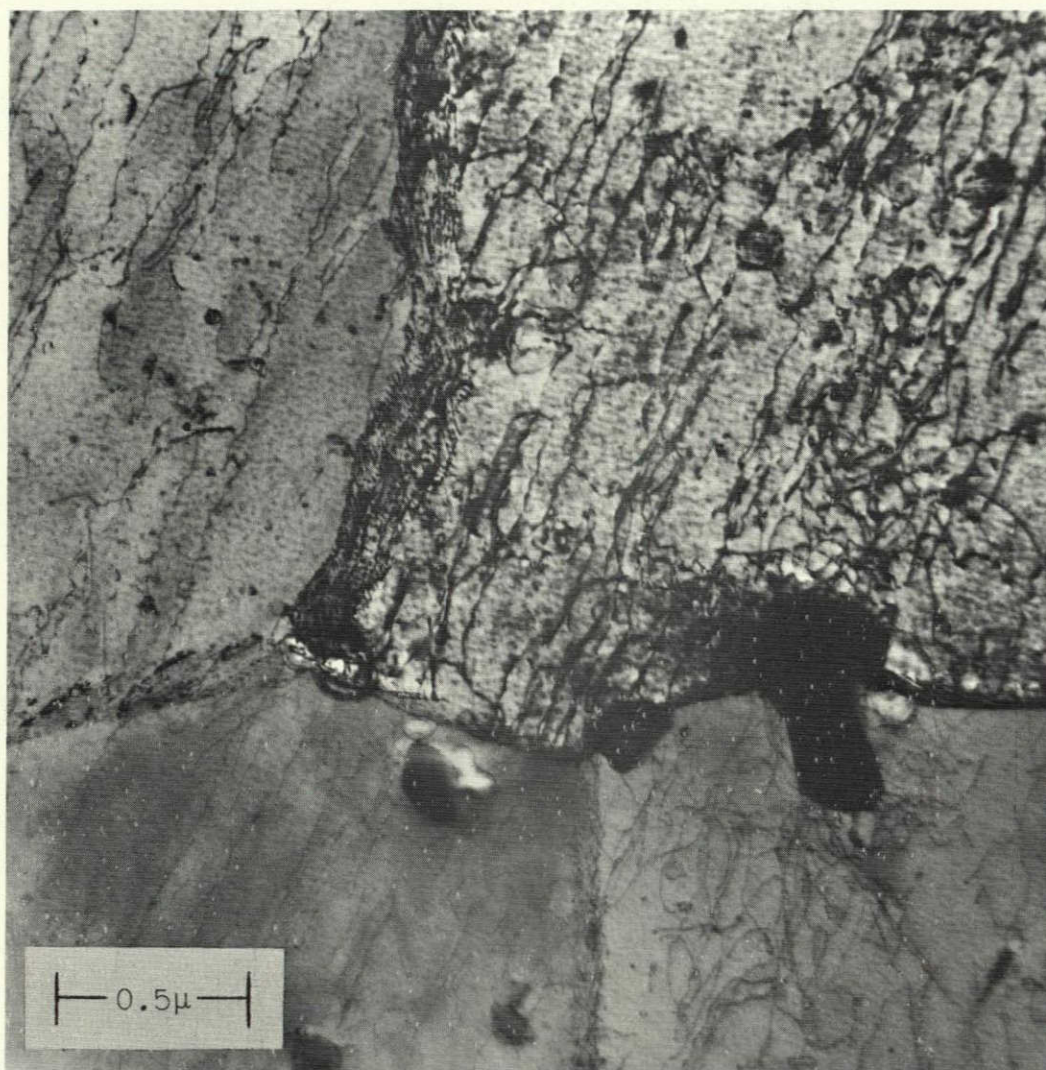
Figure 11

Electron transmission microstructure  
of 2219-T351 plate. (50,000X)

The fine structure of the 2219-T351 plate was characterized by a relatively small number of dislocations and a few comparatively large precipitate particles on boundaries (Fig. 11). The dislocations were undoubtedly generated during the stretching of the plate because their density was that expected for the 1.5-3% stretch. The large precipitate particles on boundaries were formed during quenching and correspond to those seen in the light microstructure (Fig. 1).

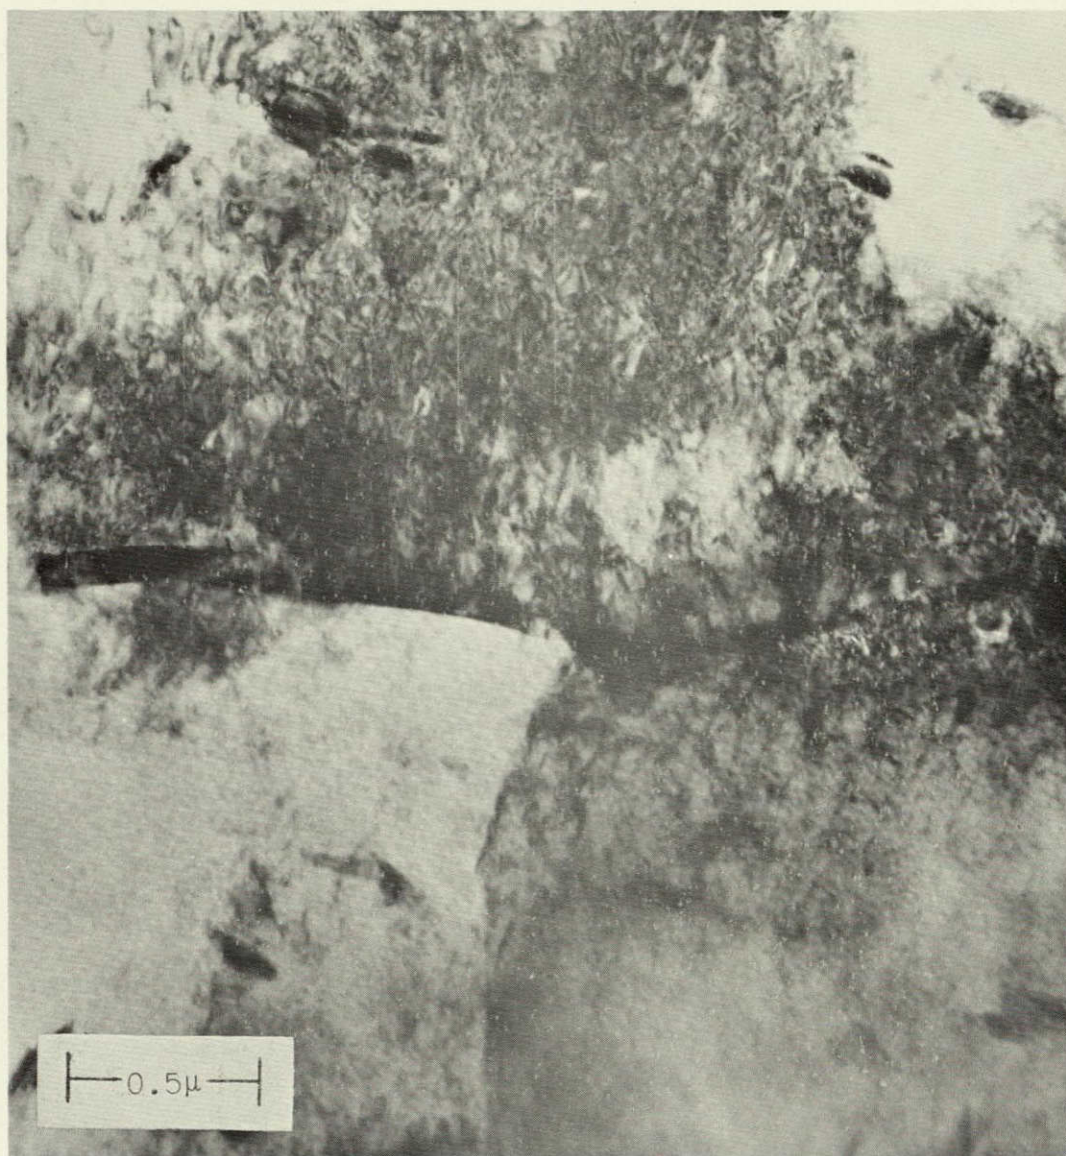
Figure 12

Electron transmission microstructure  
of 2219-T37 plate. (50,000X)

The electron microstructure of the 2219-T37 plate reflected the higher degree of cold work as compared to the T351 temper. The T37 structure was characterized by dense forests of dislocations such as those seen in Fig. 12.

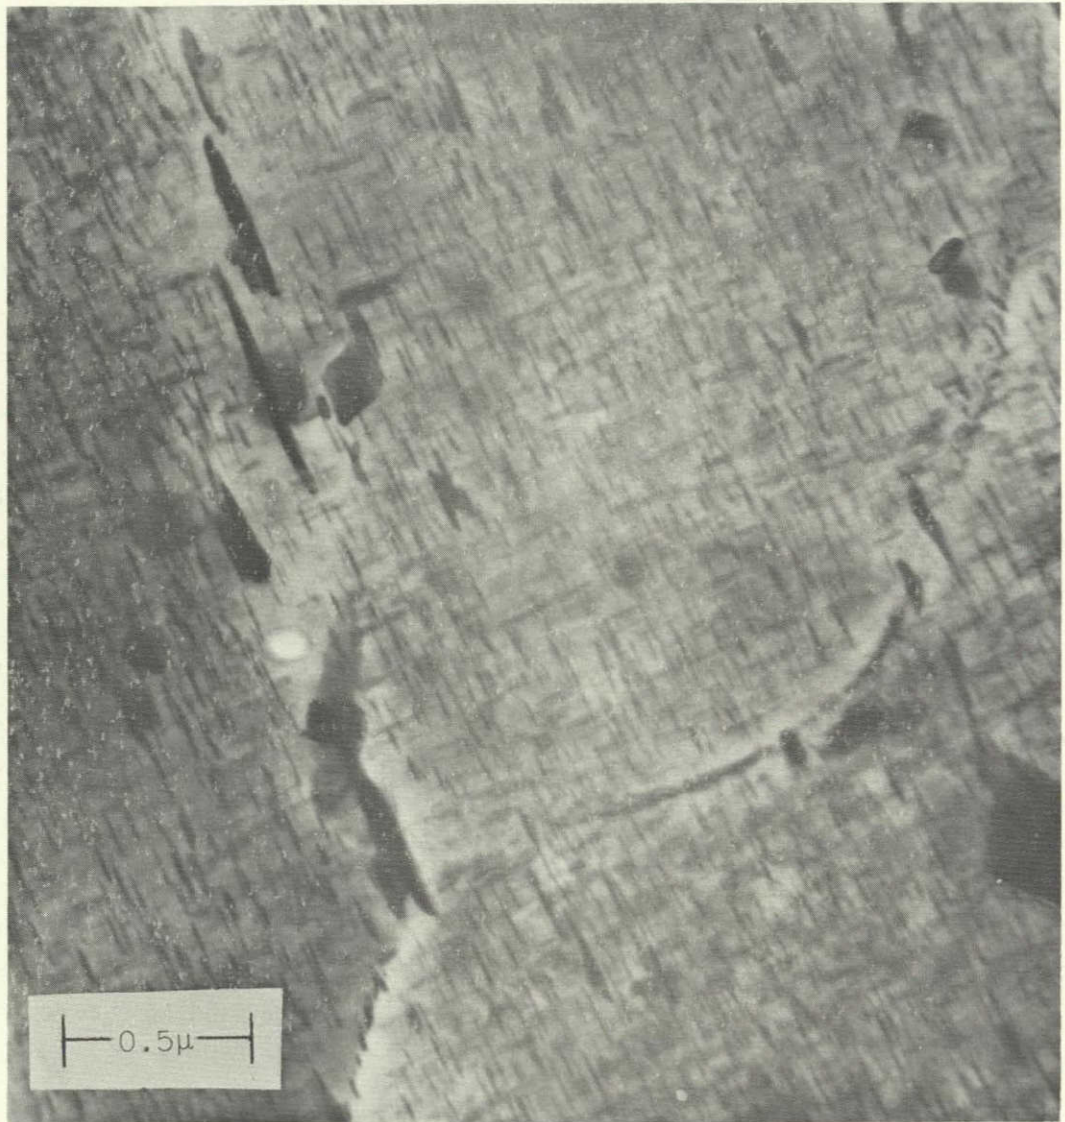
Figure 13

Electron transmission microstructure  
of 2219-T851 plate. (50,000X)

In comparing the electron microstructures of the T351 and T851 tempers, it was noted that dislocations had been eliminated by the precipitation heat treatment. From this, and the fact that stress-corrosion cracking is virtually eliminated by precipitation heat treating, it might be concluded that the improved behavior resulted from elimination of the dislocations. It should be pointed out, however, that the precipitation treatment also led to pronounced matrix depletion and the development of extensive matrix precipitate. It is much more likely that these latter major structural changes, rather than elimination of dislocations, per se, brought about the improvement in stress-corrosion behavior.

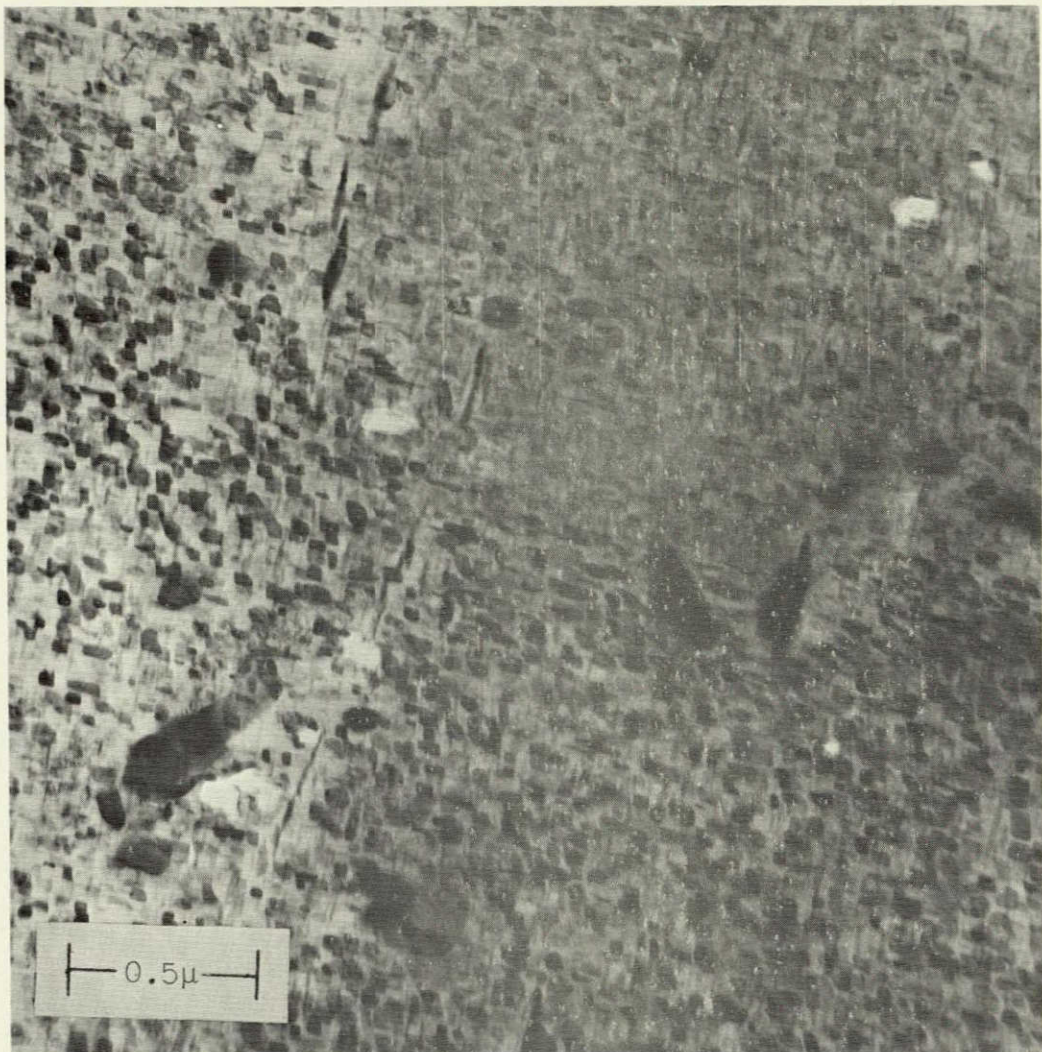
Figure 14

Electron transmission microstructure  
of 2219-T87 plate. (50,000X)

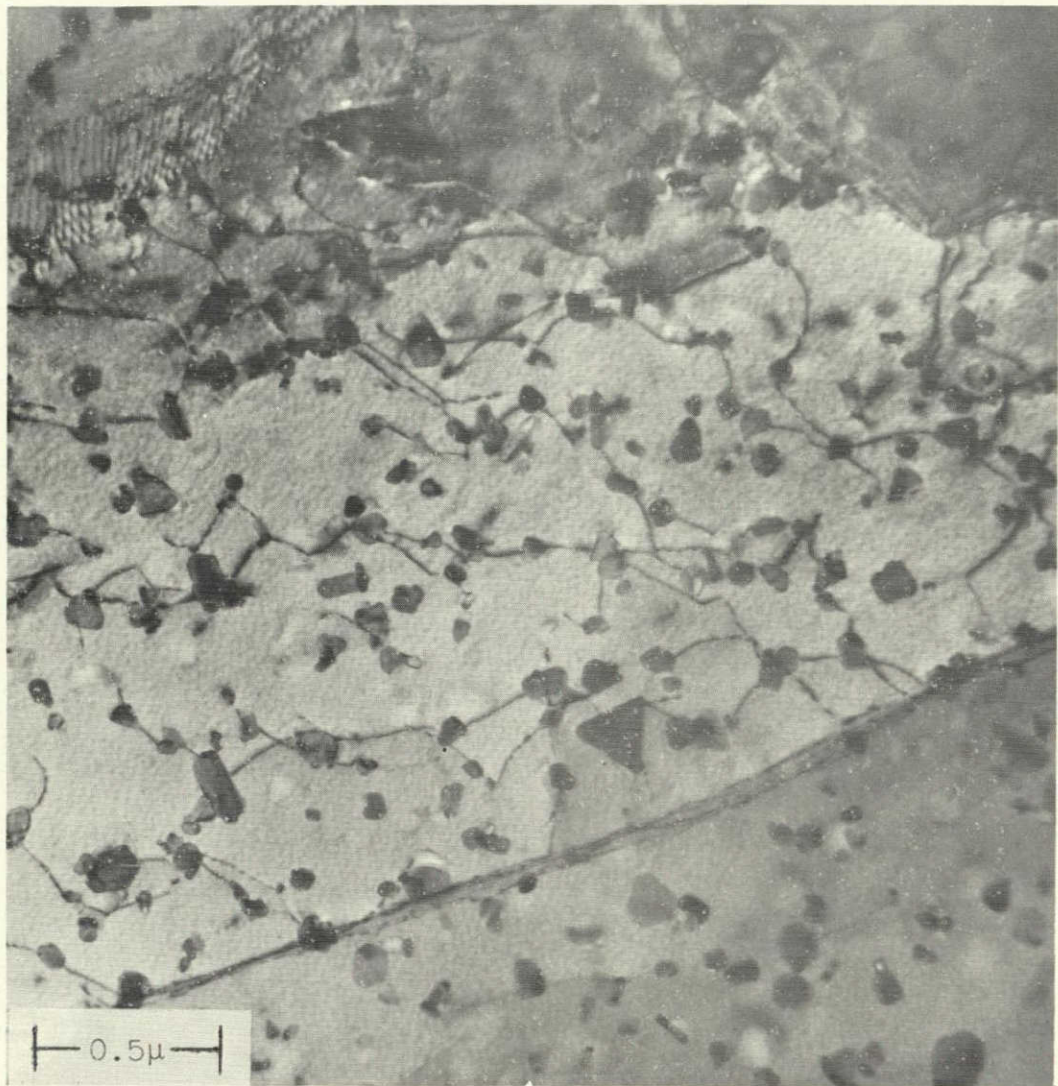
Figure 15

Electron transmission microstructure of  
7075 plate in W temper. (50,000X)

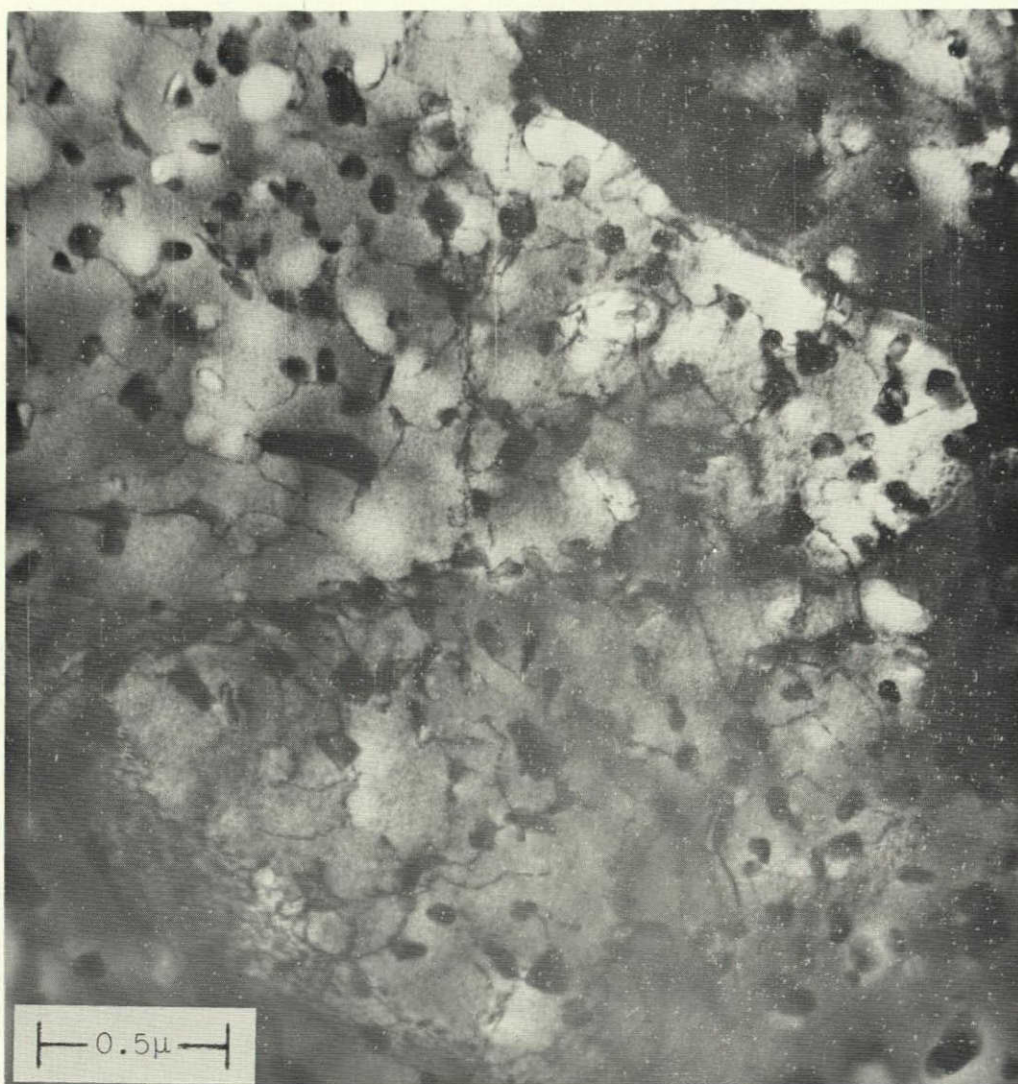
Figure 16

Electron transmission microstructure of  
7075-T6 plate showing dislocation structure.  
(50,000X)

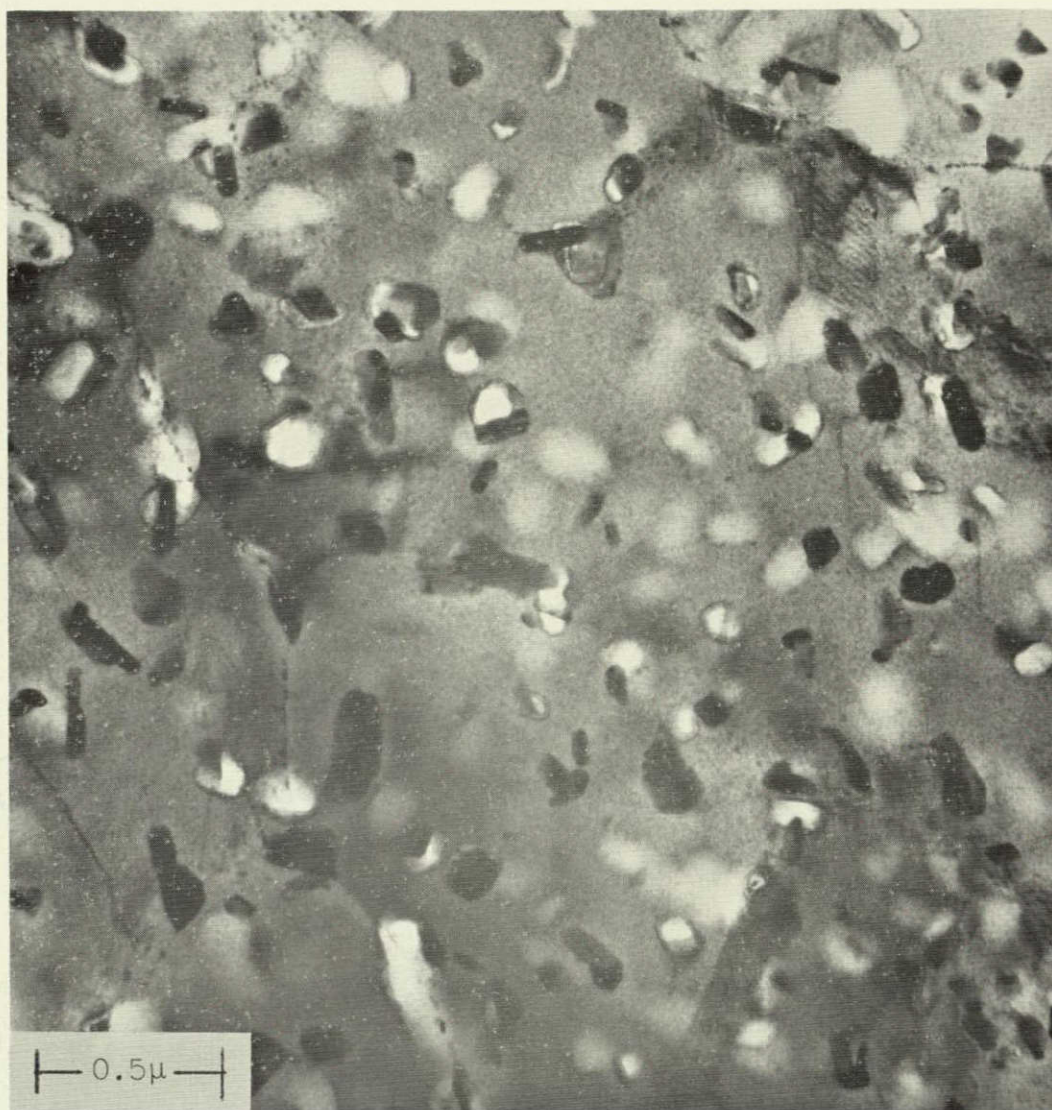
Figure 17

Electron transmission microstructure of 7075-T6 plate showing zone and precipitate structures. (50,000X)

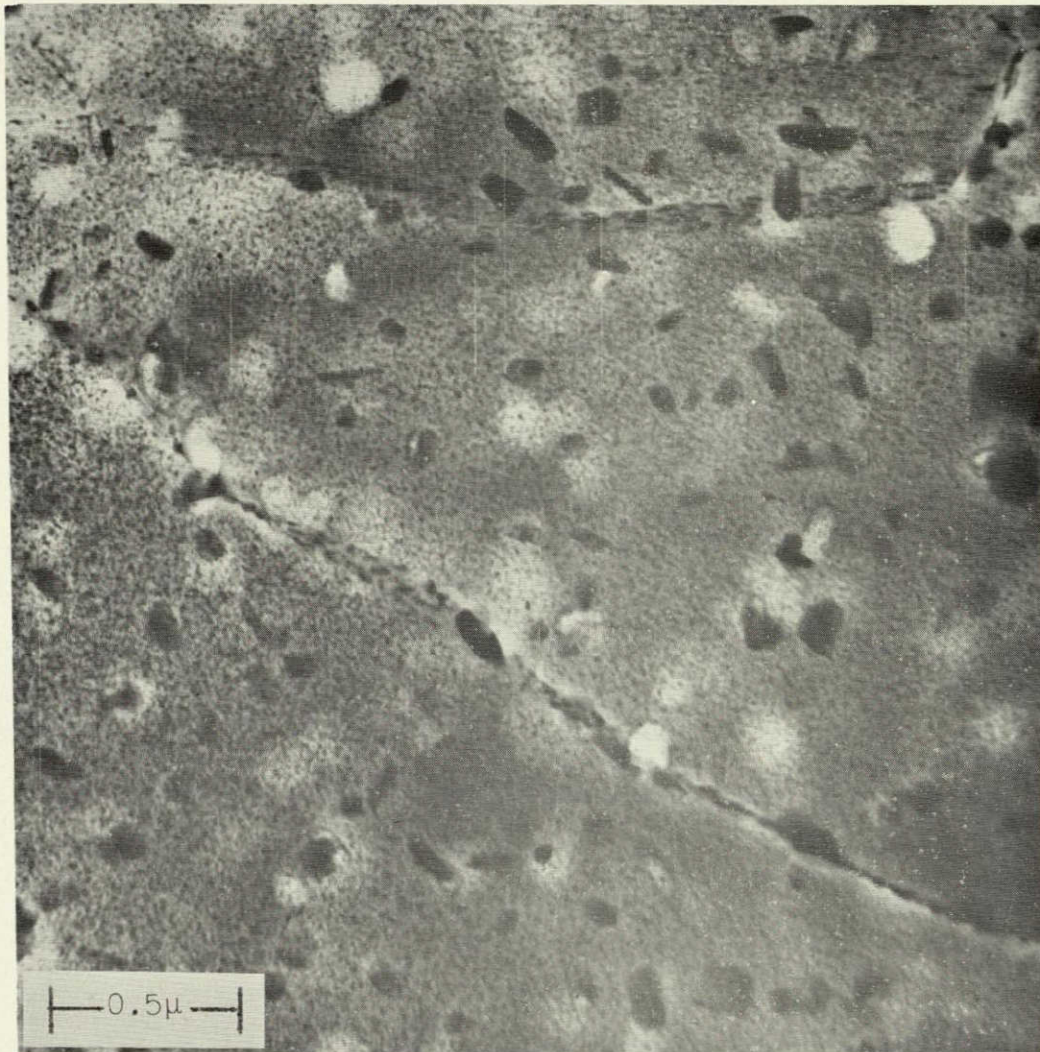
Figure 18

Electron transmission microstructure of  
7075 plate in T73 temper. (50,000X)

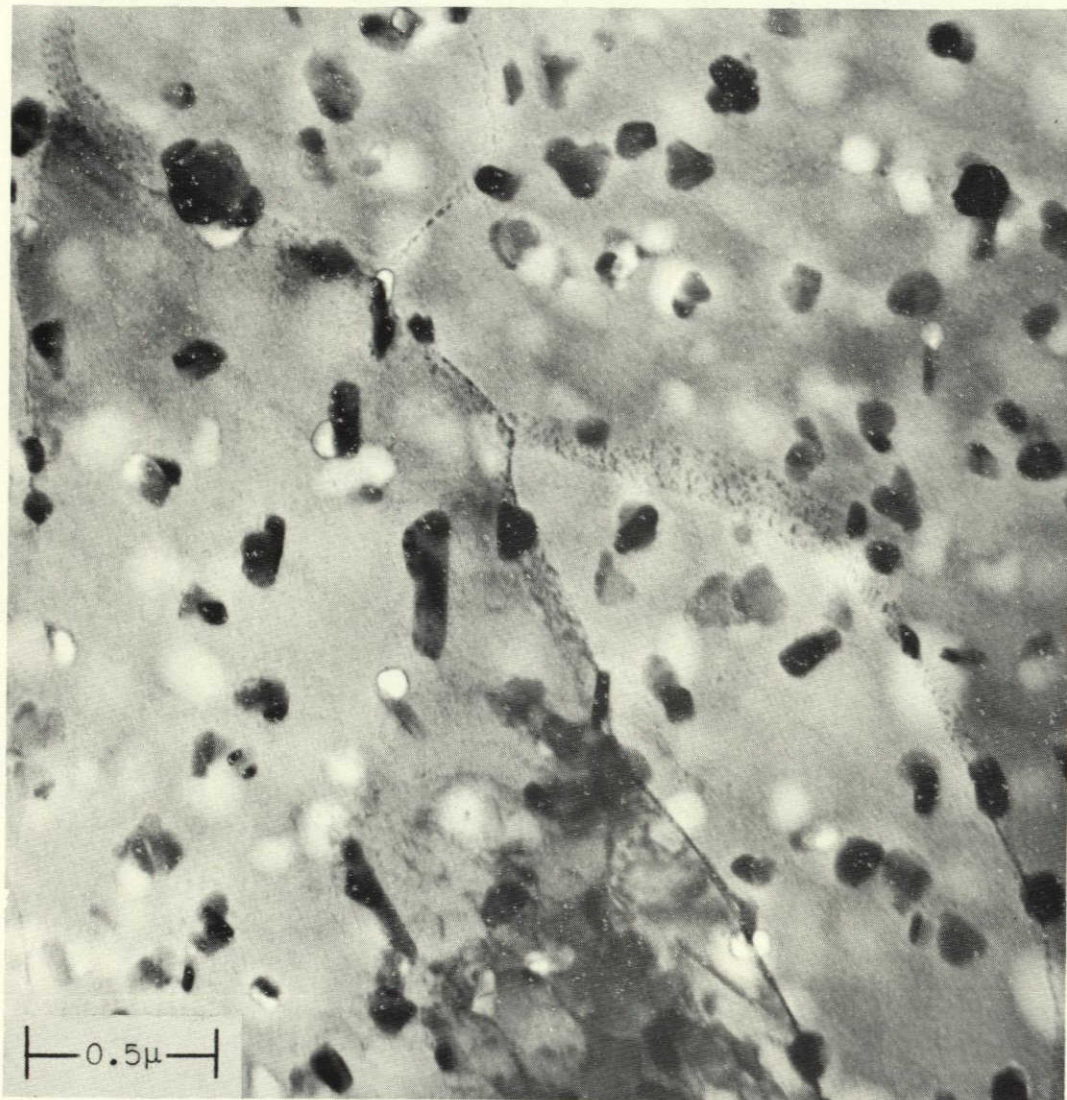
Figure 19

Electron transmission microstructure of 7079-T6 plate showing dispersoids, dislocations and precipitates. (50,000X)

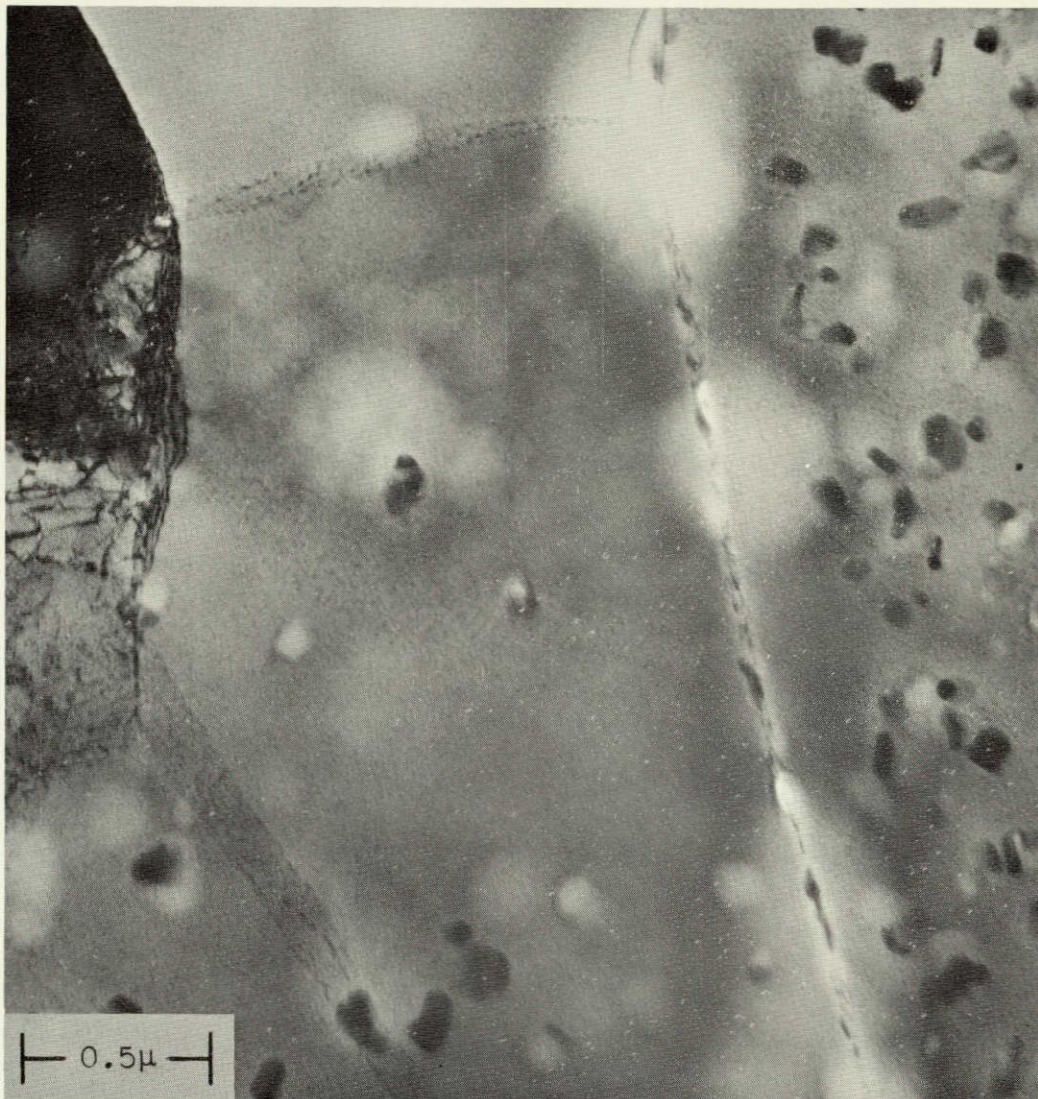
Figure 20

Electron transmission microstructure of 7079-T6 plate in dispersoid-lean region. Two sizes of boundary precipitate, precipitate-free boundary region, and fine zones in matrix are apparent. (50,000X)

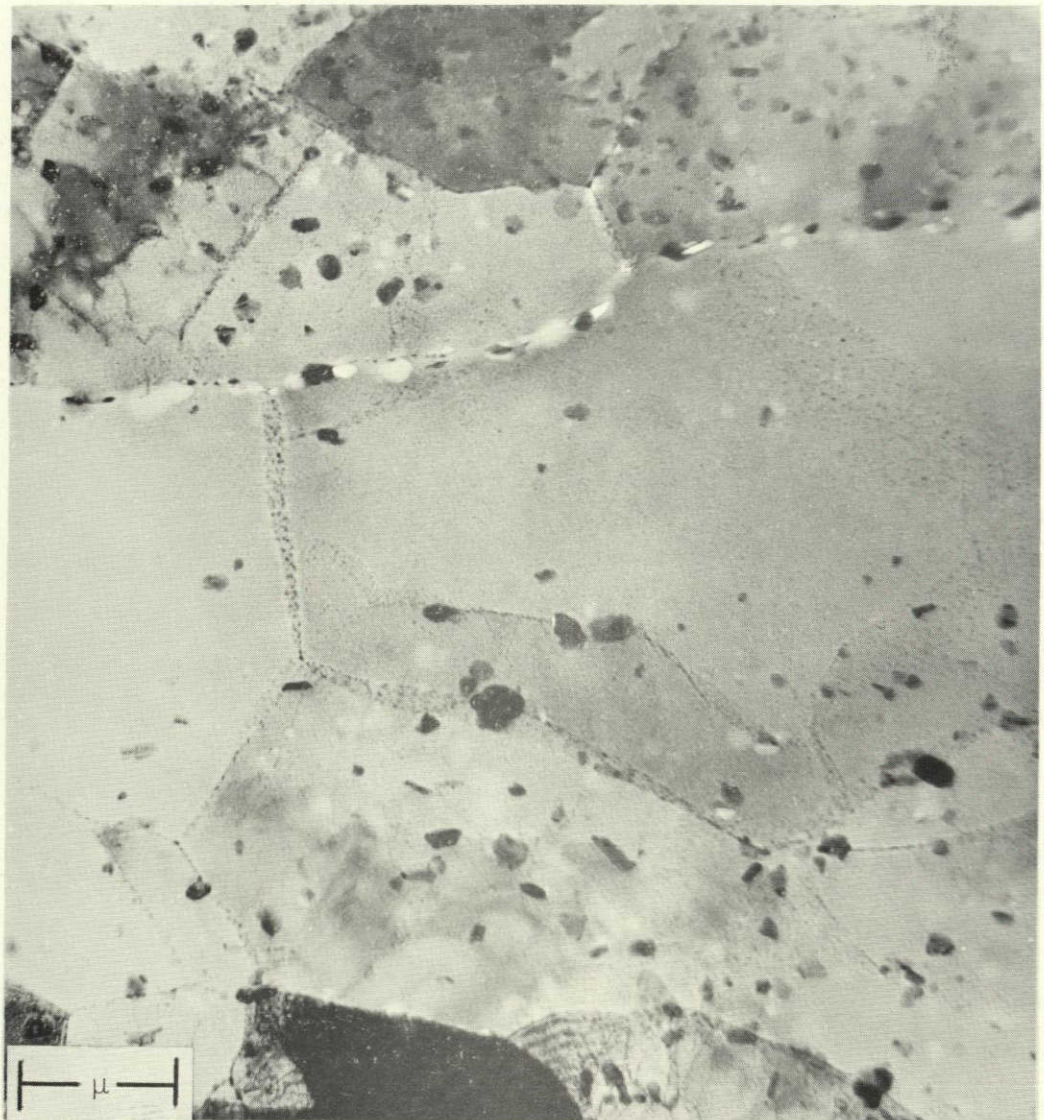
Figure 21

Electron transmission microstructure of 7039-T6 plate showing polygonized structure, dispersoid distribution and occasional dislocations. (20,000X)

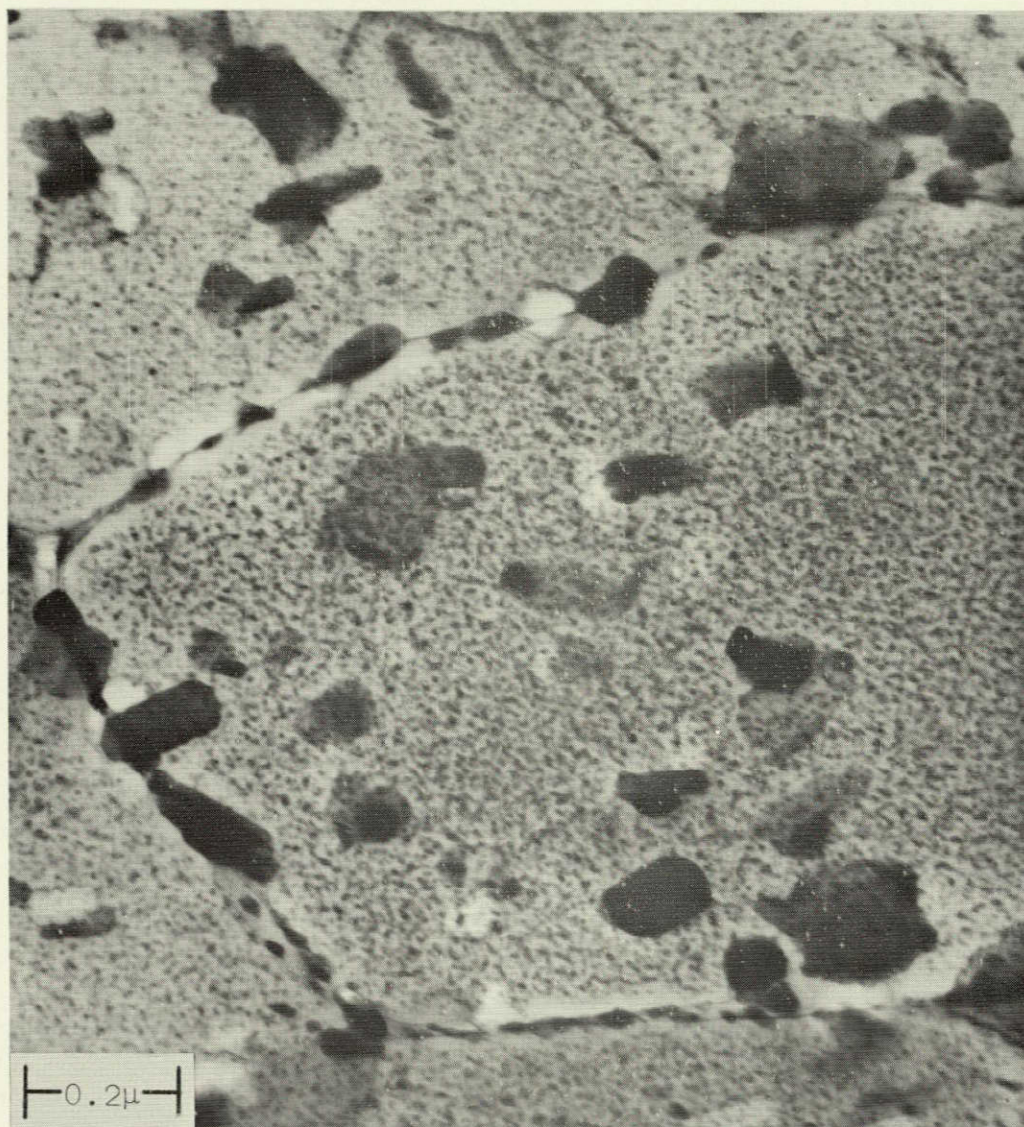
Figure 22

Transmission microstructure of 7039-T6 plate at higher magnification. Note two sizes of boundary precipitate, heavy zone-type precipitate, and precipitate-free boundary region. (100,000X)

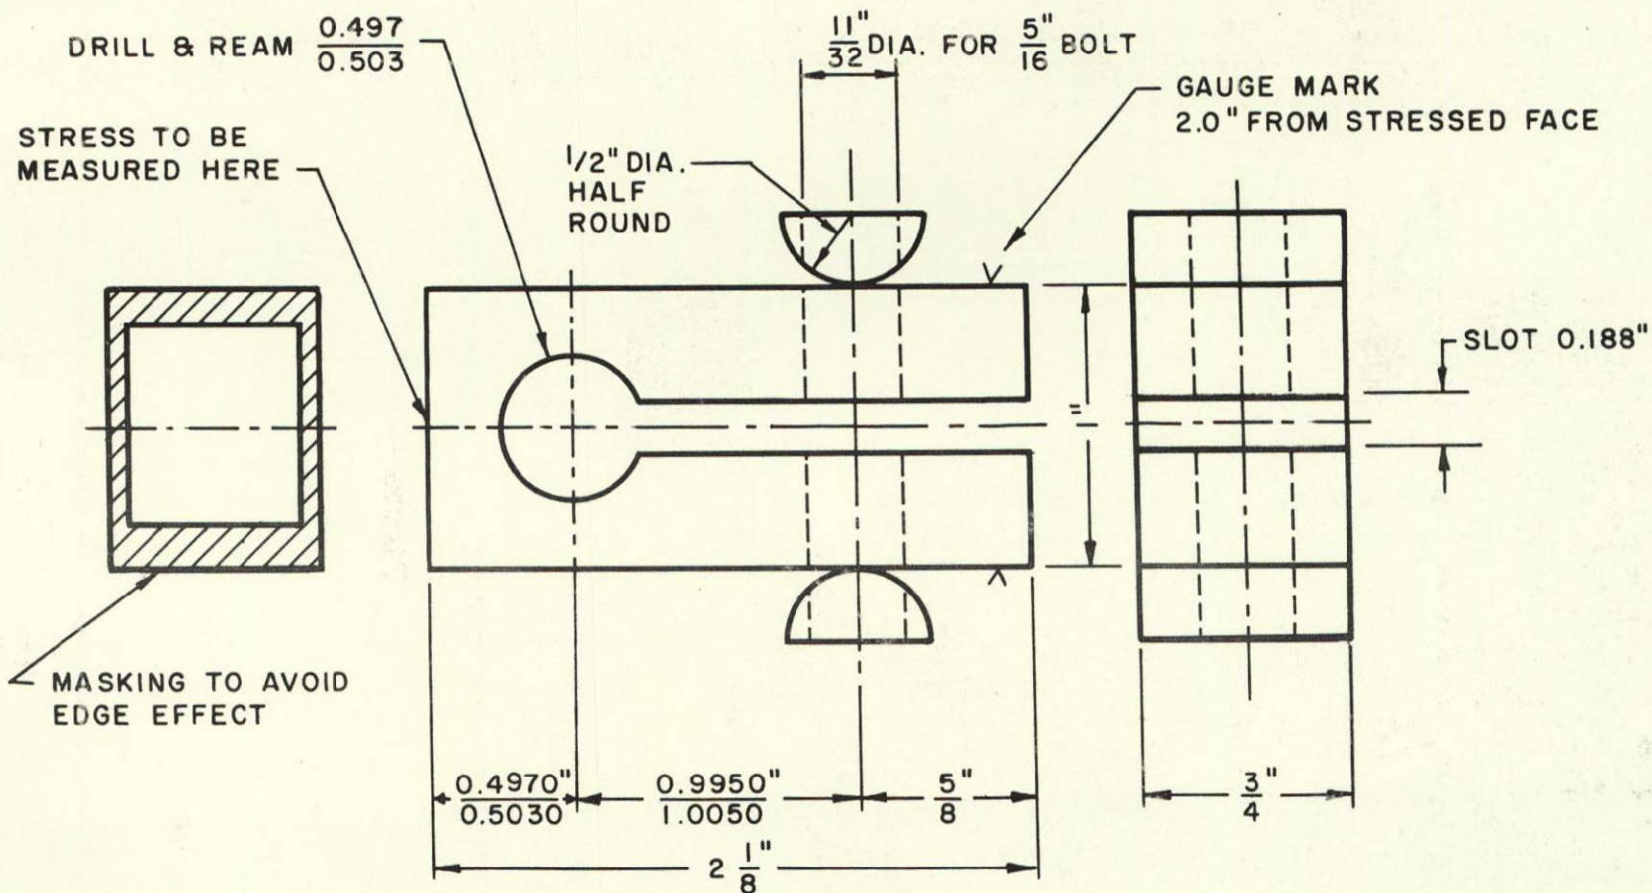
FIGURE 43

STRESS - CORROSION CRACK INITIATION SPECIMEN

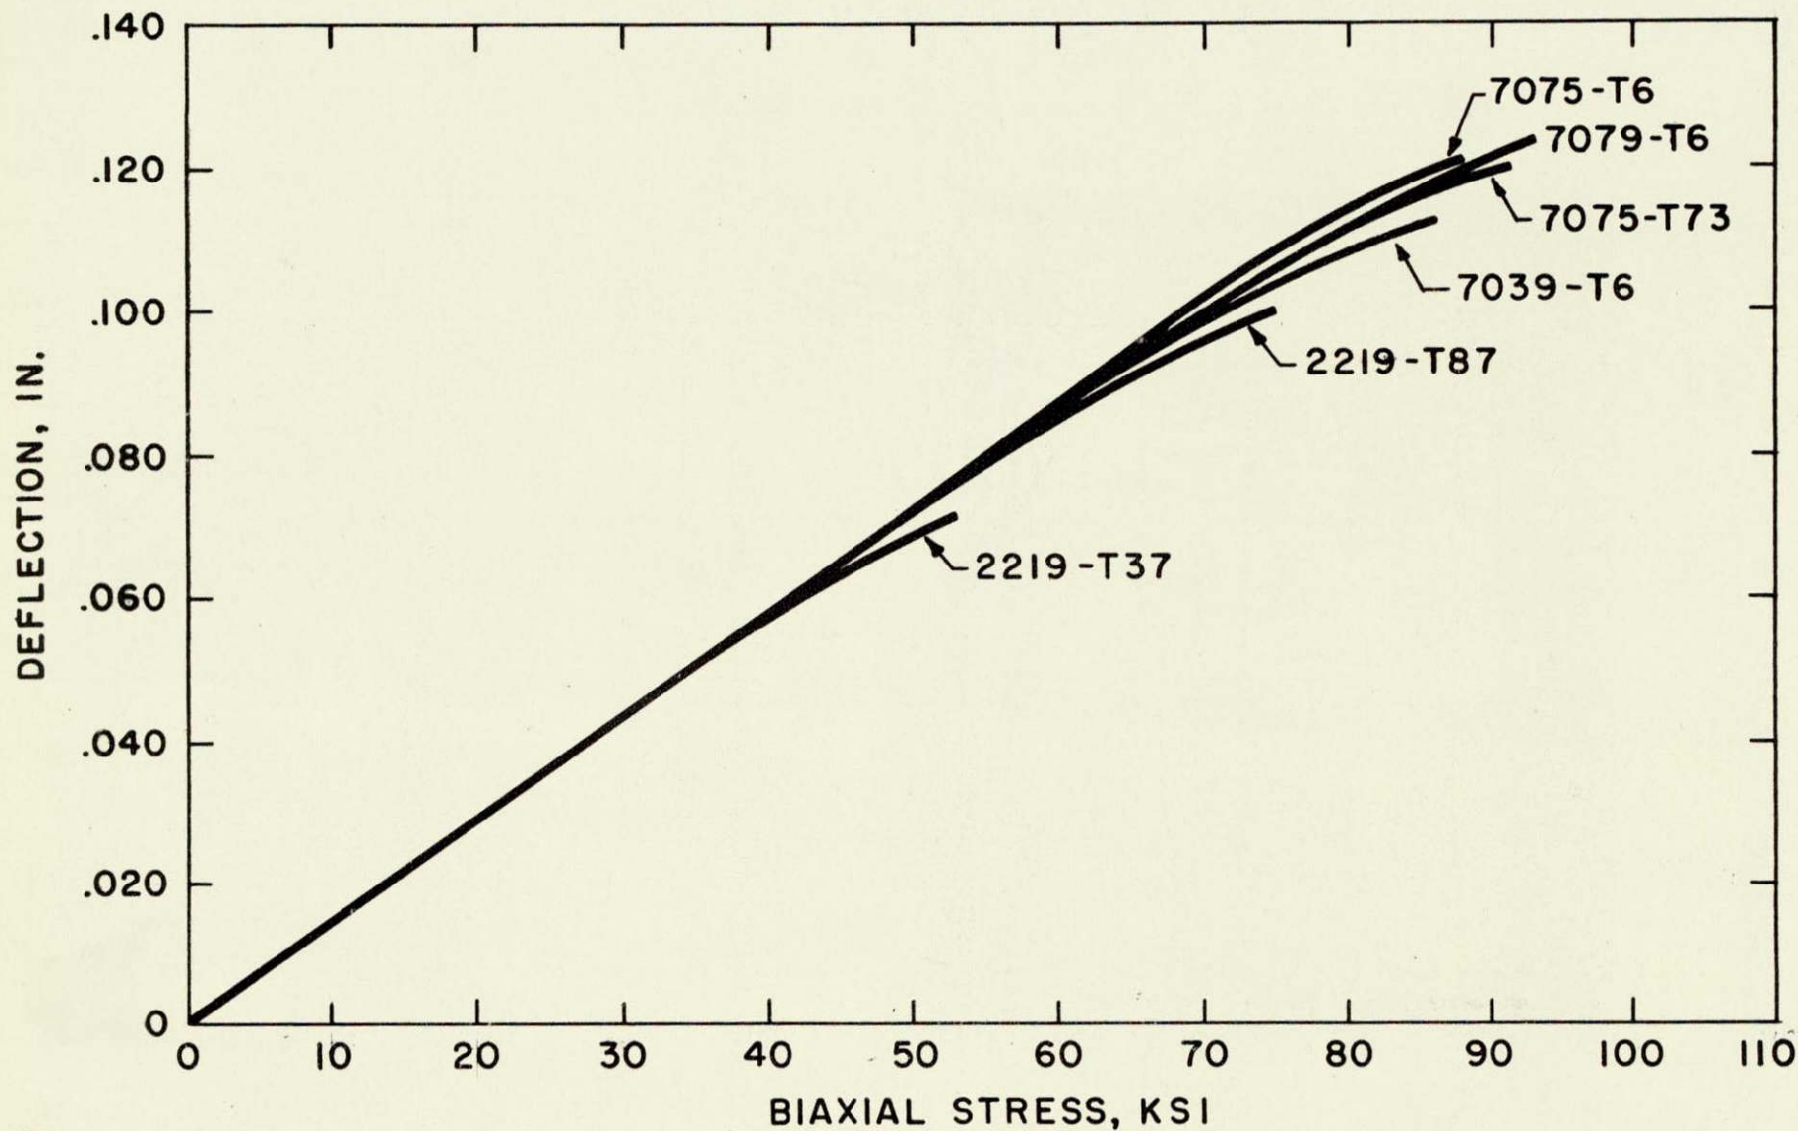
FIGURE 44

RELATION BETWEEN DEFLECTION AND SHORT-TRANSVERSE STRESS IN  
STRESS CORROSION TEST SPECIMEN

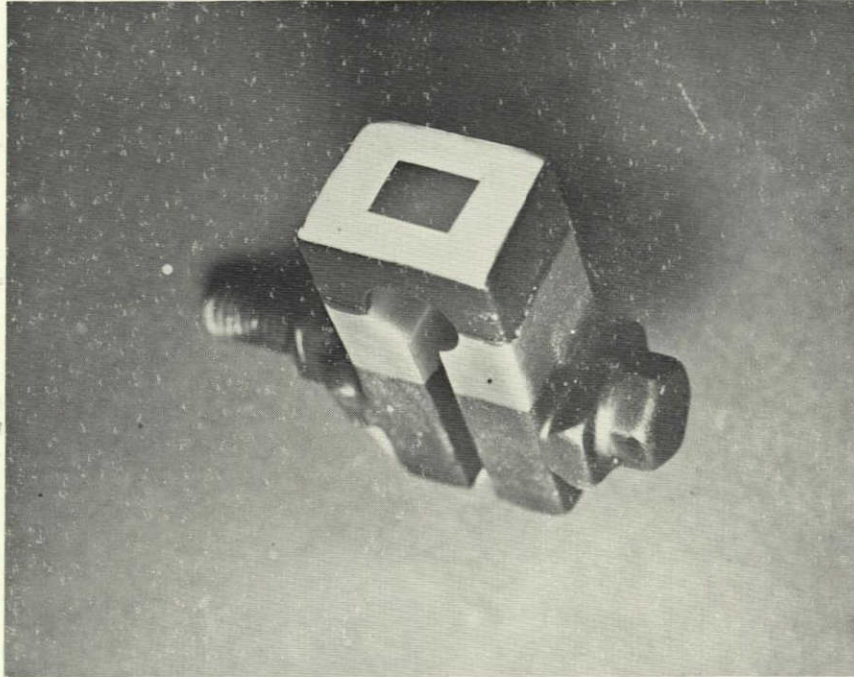
Figure 45

Stress Corrosion Test Specimen  
Prepared for Exposure

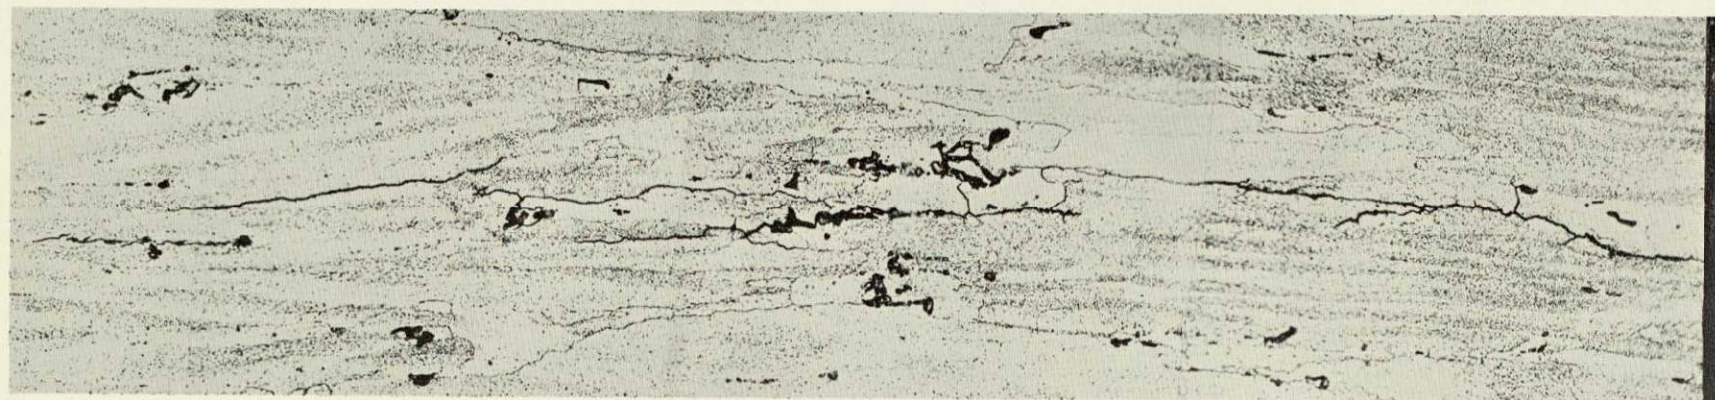
Figure 64

Cross section of sample seen in Fig. 63 showing  
crack development along boundaries. (X500)

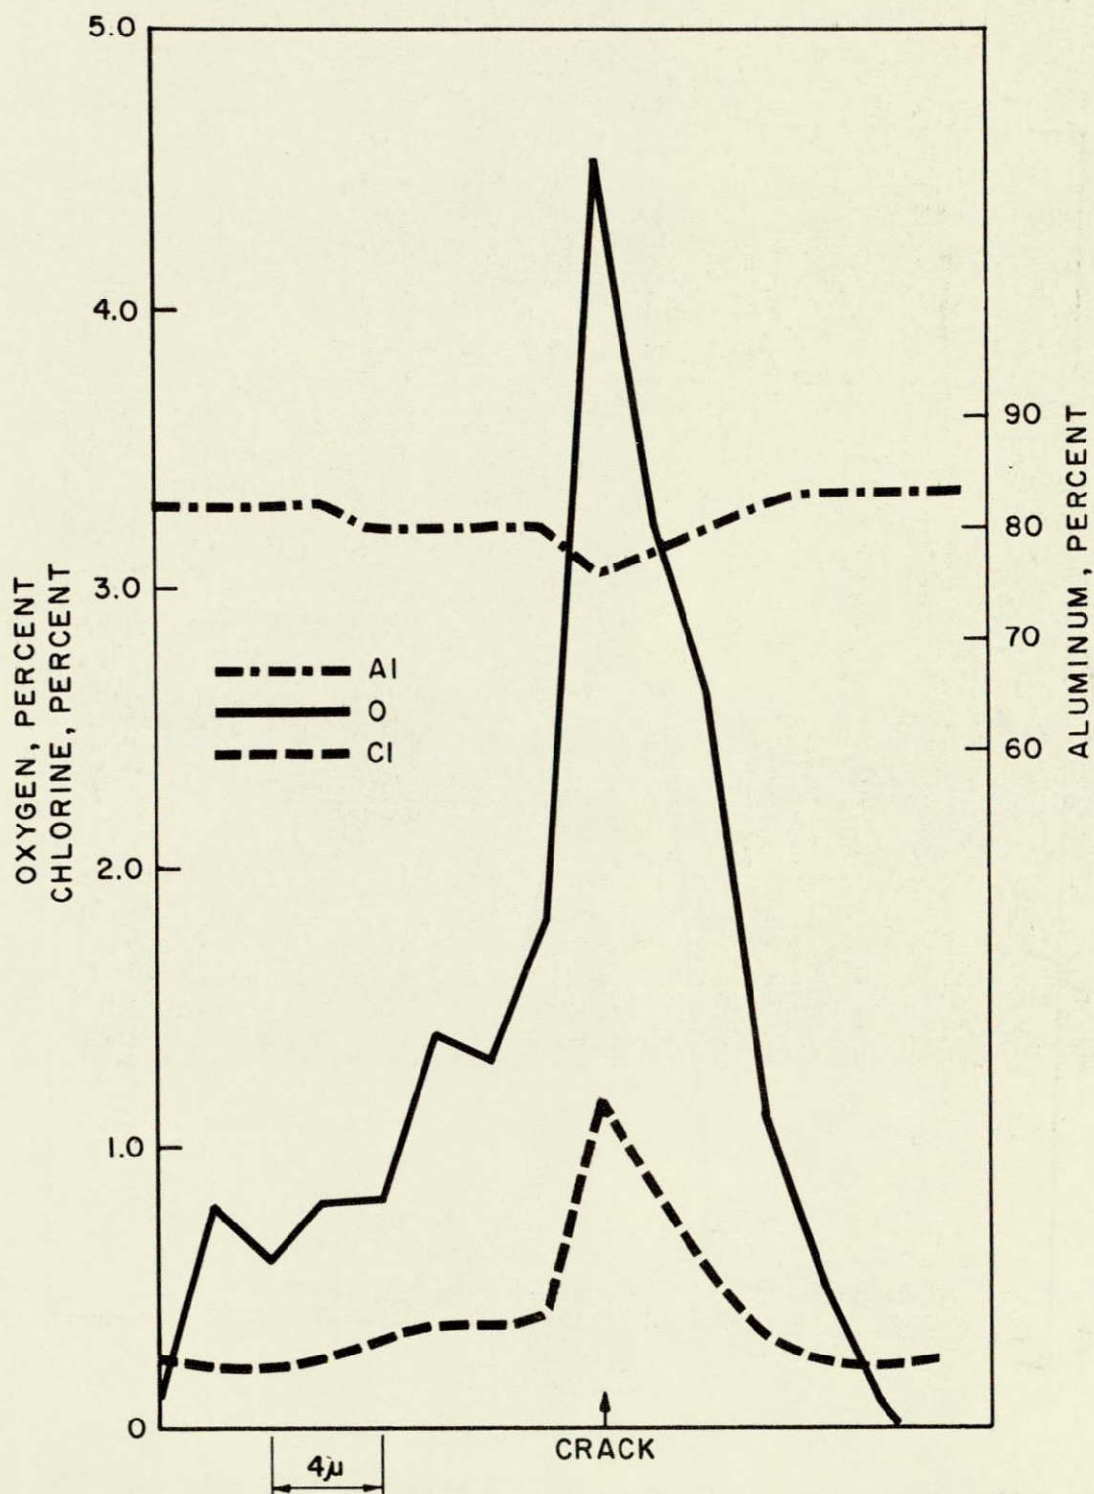
FIGURE 72

DISTRIBUTION OF Al, Cl AND O IN VICINITY  
OF STRESS-CORROSION CRACK
